The world's most rigorously tested rising damp treatment

The most tested damp-proofing cream on the market

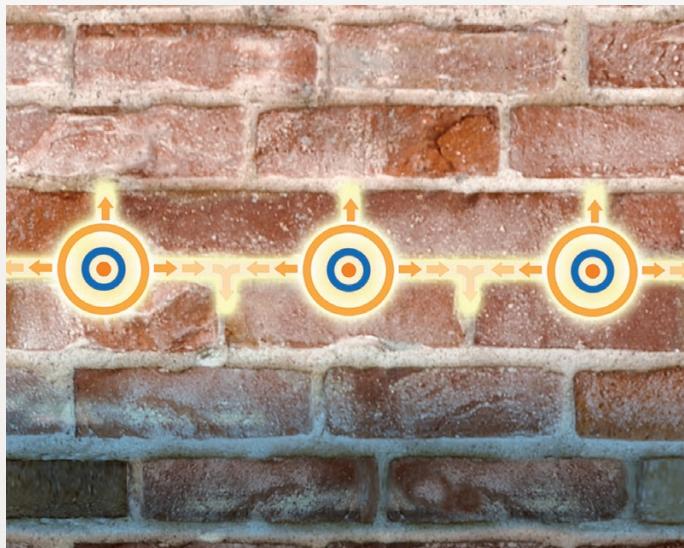
The introduction of the patented Dryzone damp-proofing cream has revolutionised the treatment of Rising Damp. The Dryzone cream is introduced by means of a simple applicator gun into a series of holes drilled into the mortar course. Once the Dryzone is installed, it diffuses to where it is most needed before curing to form a water-repellent resin.

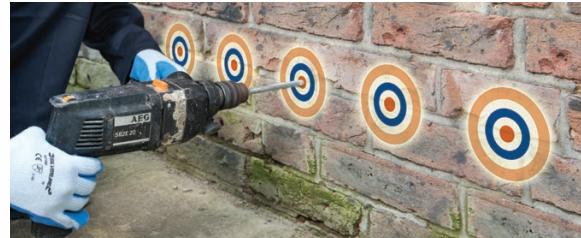
1. Drilling

First create a series of horizontal drill holes along the mortar course. Typically these are 12mm holes at 120mm spacings - refer to the Dryzone Application Instructions for details for particular wall thicknesses.

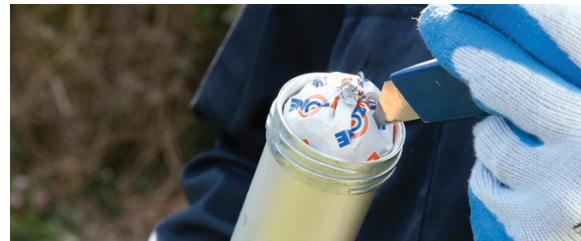
2. Preparation

Insert a Dryzone cartridge into the applicator gun, ensuring the pressure piston is fully extended. Cut into the end of the cartridge so that cream will be able to flow freely. Screw the nozzle cap back onto the gun.

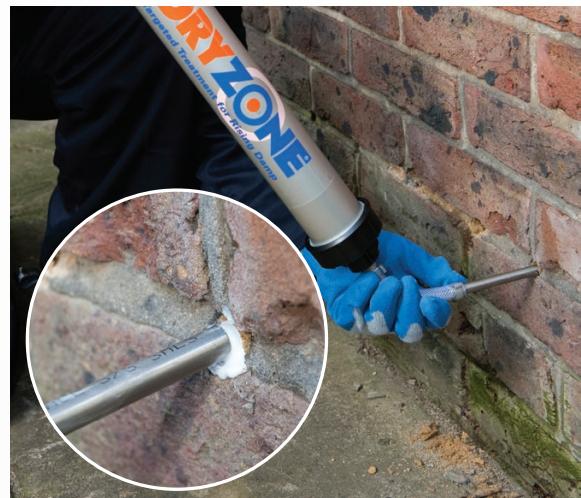
3. Injection

Fully insert the nozzle into the first drilled hole, and then inject Dryzone cream while withdrawing the nozzle at a steady rate. Stop injecting just before removing the nozzle from the wall. Repeat for remaining holes.
